These instructions feature an Access High-Low Exam Table. The process for replacement or repair of an Access Flex Exam Table will be the same.

Stirrup Dis-Assembly:

Stirrup Assembly:

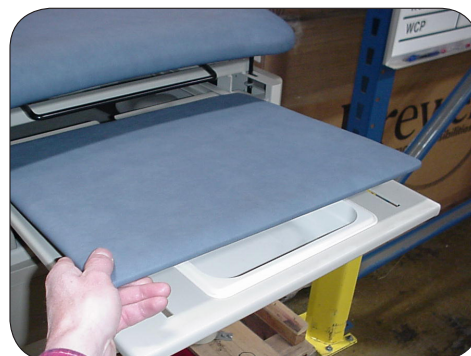
1. Fully extend the leg support from the table.
2. Remove toe board upholstery.

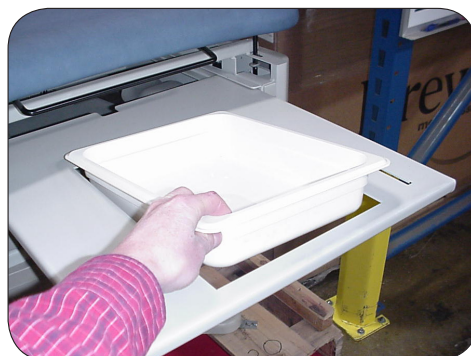
3. Remove the treatment pan.

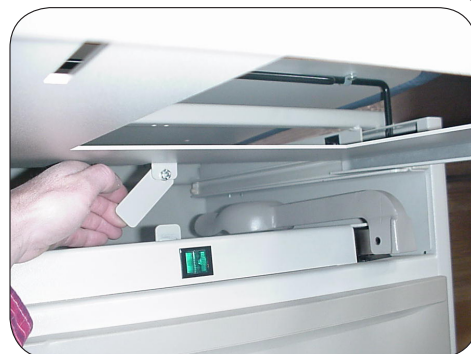
4. Slide the bracket stop to the left or right and pull out the toeboard weldment.

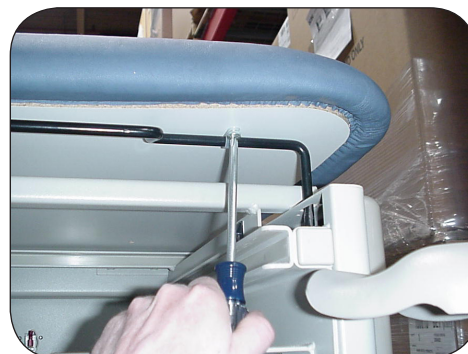
5. Remove the two screws that attach the pelvic tilt bar to the seat upholstery underside. (Tables with drawer warmer option only.)

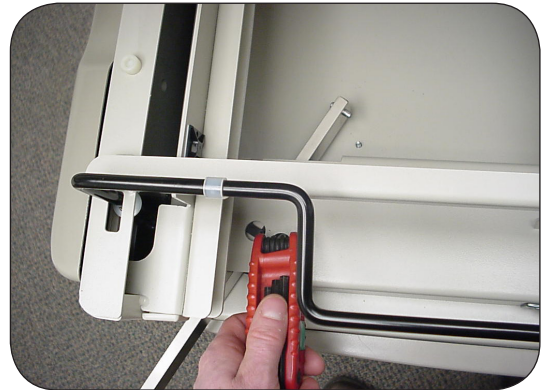
Cut Away Top View of Leg Support (shown in step 4)

7. Position seat upholstery on an incline for easier access to stirrup hardware.
8. Remove (2) screws that secure Stirrup assembly to the table. Slide stirrup assembly out from table. Note: do not reuse the Allen head screws. Use the new Philips head screws included in the service kit.

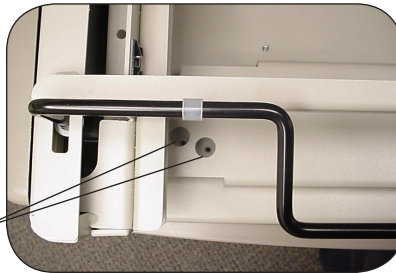
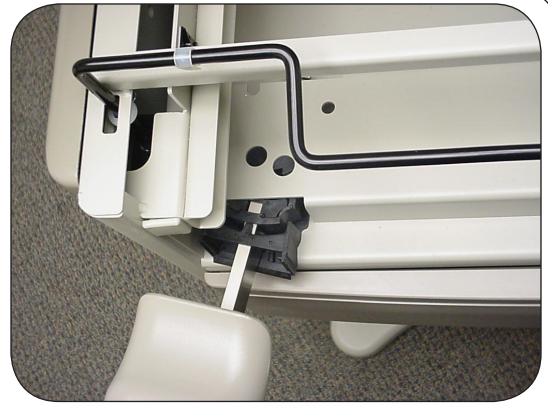
Mounting holes

1. Insert new stirrup assembly into table. Align mounting holes and secure with (2) #10-24 x 1" Philips head screws.

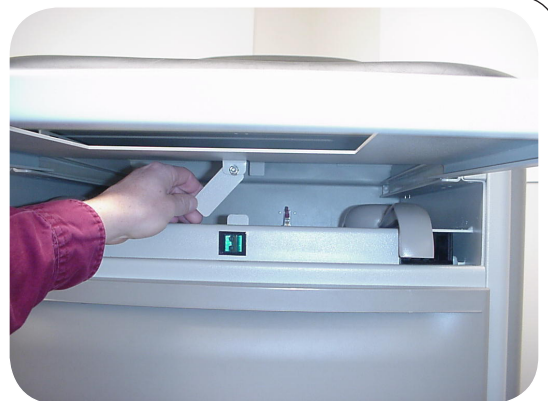
2. Slide bracket stop to the side and insert toe board weldment (if so equipped).
3. Release bracket stop to a vertical position.

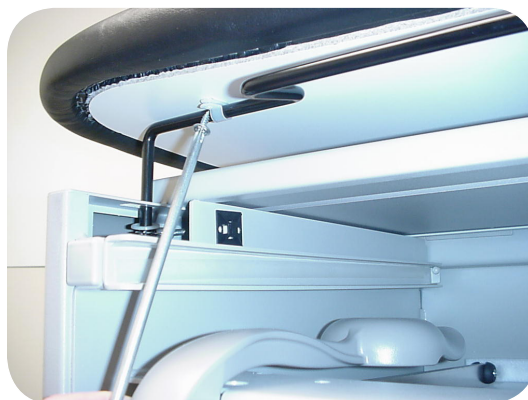
4. Re-attach the pelvic tilt bar. (Tables with drawer warmer option only.)

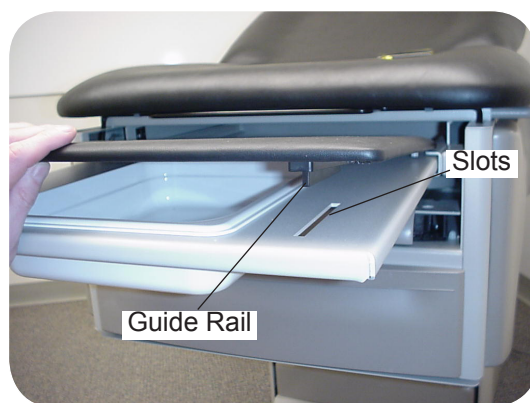
5. Install treatment pan into toe board weldment opening.
6. Position toe board upholstery over treatment pan. Ensuring guide rails are in the grooved slots of the toe board weldment.
